## 10. PERMAFROST

**Thomas E. Osterkamp**, Geophysical Institute, University of Alaska Fairbanks

### 10.1 Introduction

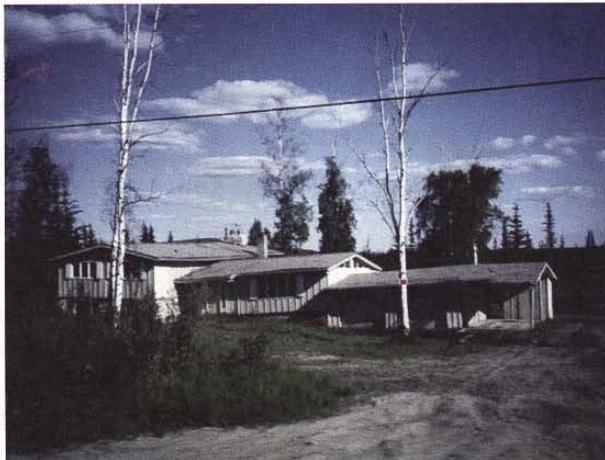
Figure 10.1. This house damaged by thermokarst in the Fairbanks area had to be abandoned.

- ◆ Abandoned and damaged houses in Alaskan communities (Fig. 10.1).
- ◆ Abandoned building at a radio transmitter site near Fairbanks.
- ◆ Abandoned hospital in Kotzebue.

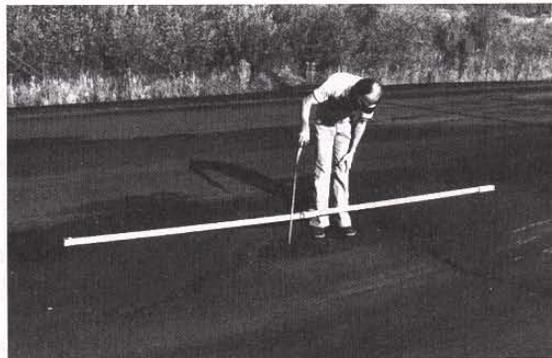
Figure 10.2. Thawing of ice-rich permafrost and the resulting thermokarst caused this road to settle which required repeated patching to keep the road in service.

- ◆ Abandoned and damaged roads and bridges (Fig. 10.2).
- ◆ Specialized and more expensive construction methods for roads, airports, pipelines and other structures (Fig. 10.3).

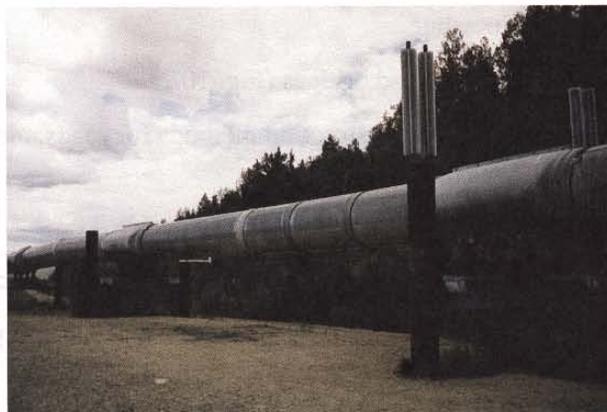
Figure 10.3. Trans-Alaska pipeline showing the above ground portion of the pipe supported by naturally refrigerated pilings. This expensive construction mode was required because of the presence of ice-rich permafrost which had to be kept frozen.

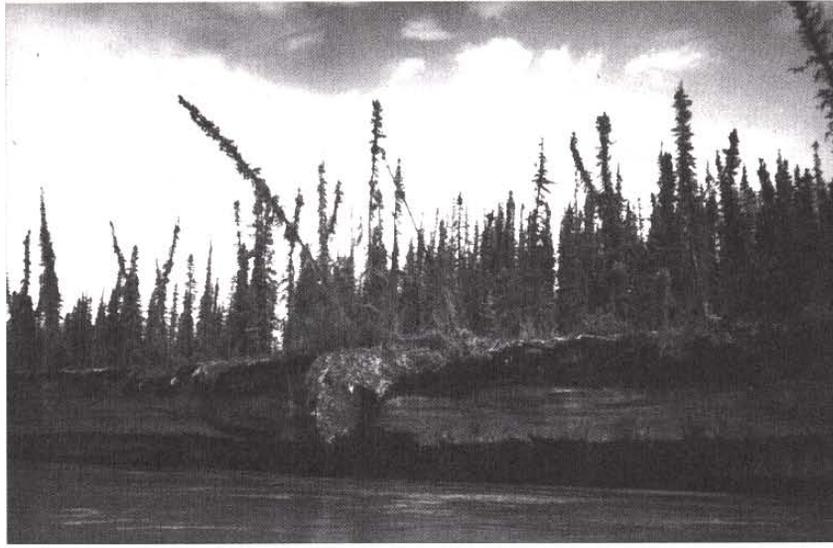
Figure 10.4. This river bank in ice-rich permafrost has been undercut a distance of several meters. The bank will eventually collapse putting trees, shrubs, organic material and large volumes of silt into the river increasing the sedimentation problem.

- ◆ Thermokarst damage to agricultural fields.
- ◆ Increased sediment loads and siltation in rivers (Fig. 10.4).
- ◆ Destruction of trees in the boreal forest (Fig. 10.5).

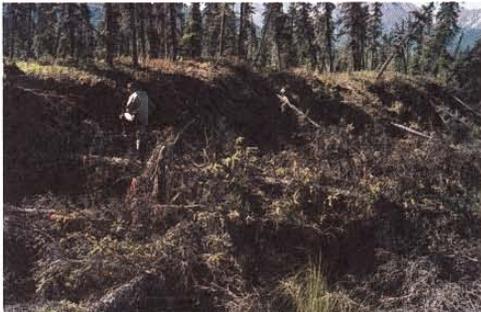
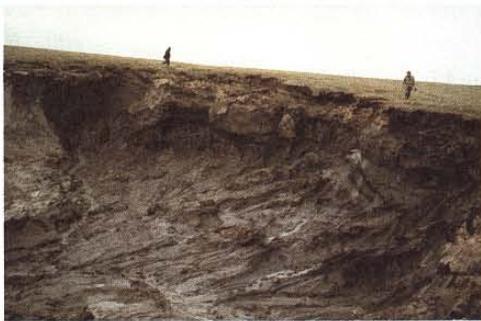
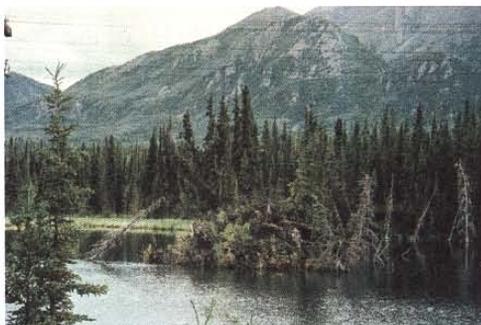
Figure 10.5. Examples of how existing ecosystems have been destroyed and are being replaced by new ecosystems as permafrost thaws:

- a. Active thermokarst that is altering the boreal forest near Tok, Alaska, in an area of warm, discontinuous permafrost;
- b. Active thermokarst in an area of continuous permafrost on the Gydan Peninsula, Russia;
- c. An active thermokarst that has resulted in a pond. More than 5 m of vertical settling occurred. Note the dead trees in the water and tilted trees on the island, indicating that settling is still in progress (photos by Tom Osterkamp)

- ◆ Ecosystem damage and destruction such as that occurring in the Tanana Flats, Mentasta, Healy and Cantwell areas (Fig. 10.5).
